BRIDGE INSPECTION

For
2014 Bridge
Inspections

City of Afton, Minnesota

.....
WSB Project No. 01856-17

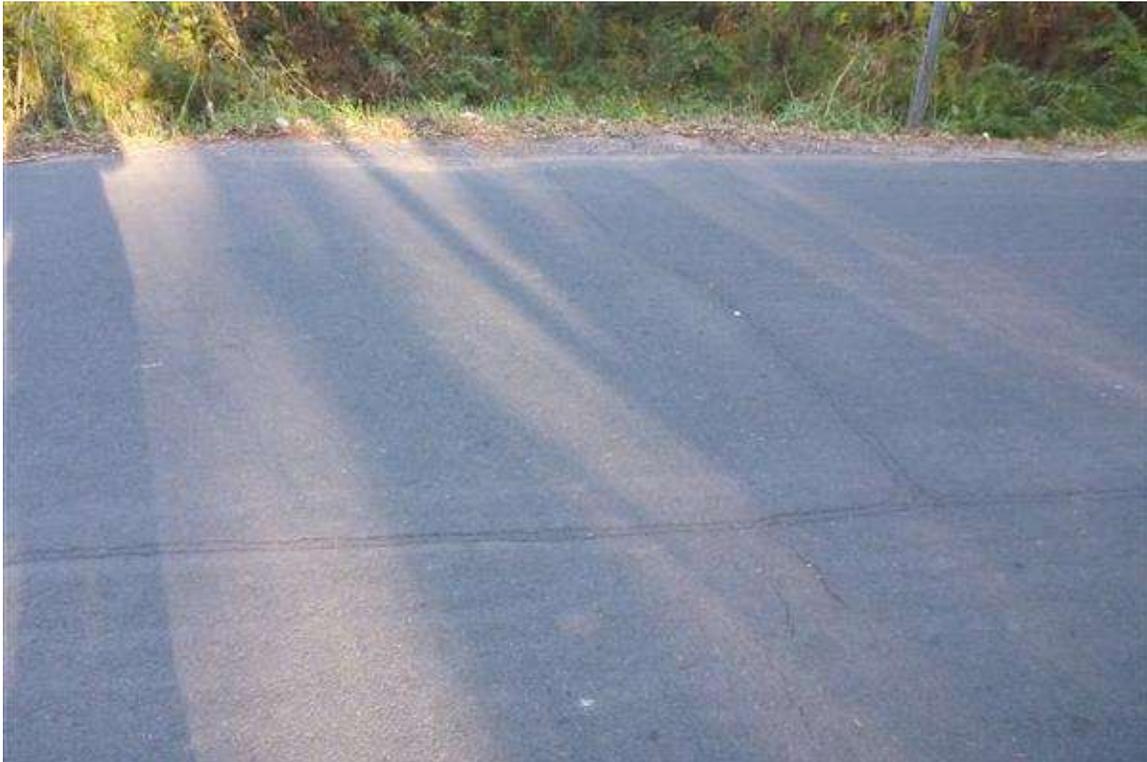
Notes: [2014] Longitudinal crack down middle and transverse crack at midspan.

Photo 2 - Top of Roadway. Long. crack down middle with transverse crack at mid span.

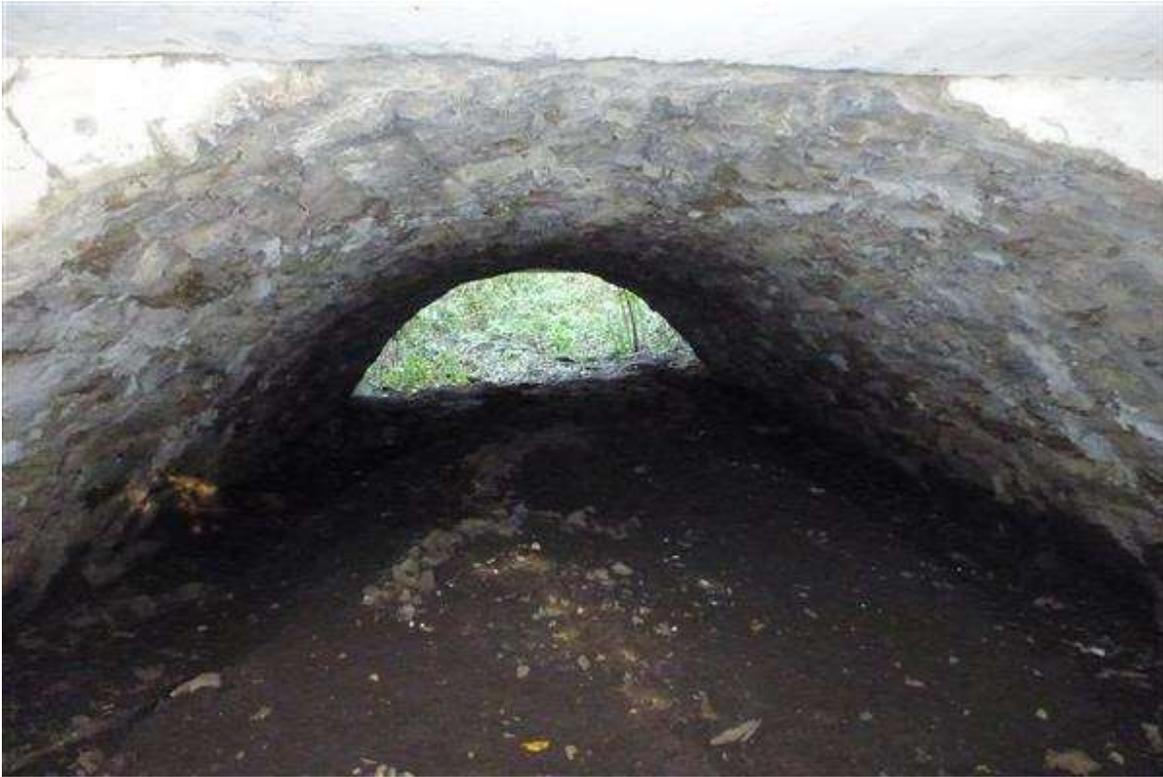
62. Culvert NBI: [2013] Masonry has recently been repaired and tuckpointed.
 [2014] Culvert is structurally sound but has extensive weathering/scaling.

Photo 5 - Looking inside arch. (Looking East)

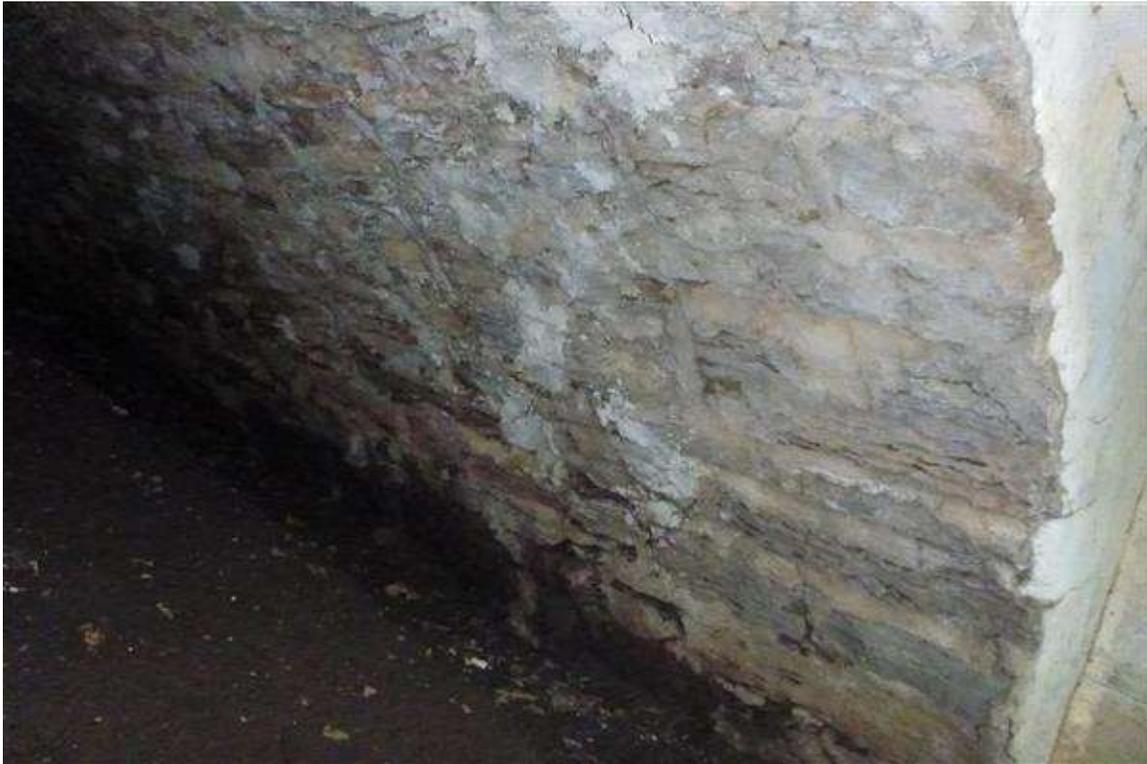
Photo 6 - Looking inside arch. (Looking East)

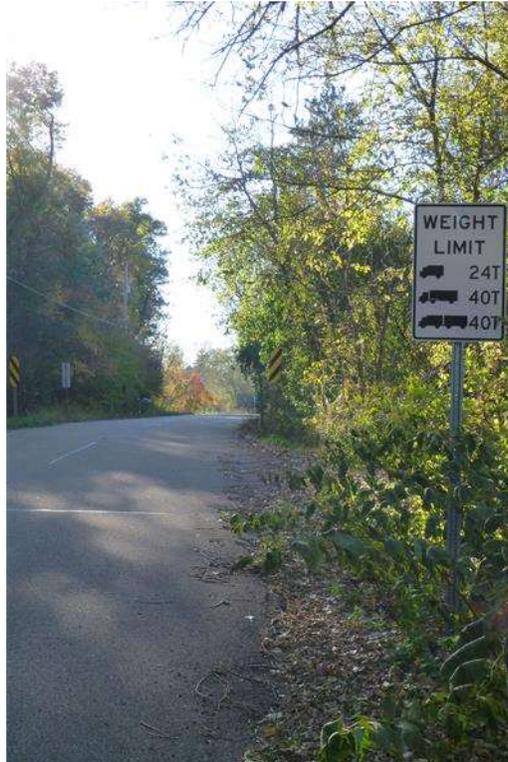
Photo 2 - East Approach (Looking West). Load Posted at 24T-40T-40T.

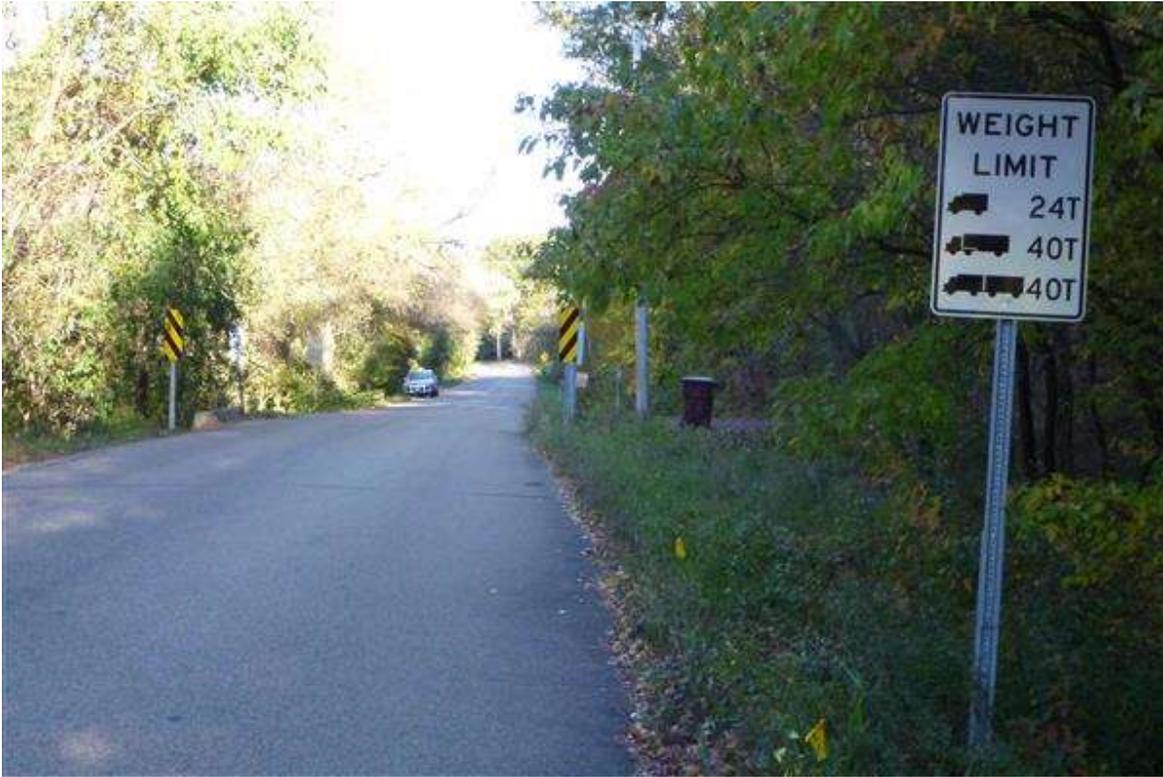
Photo 3 - West Approach (Looking East). Load Posted at 24T-40T-40T.

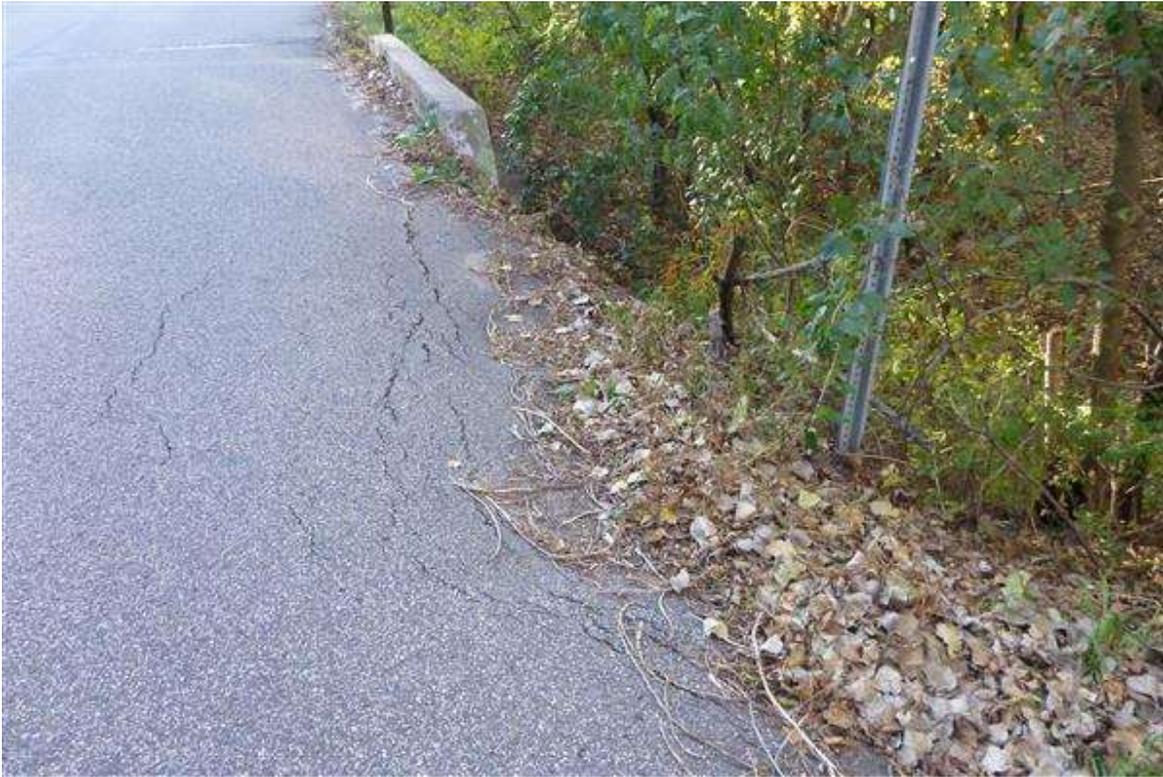
Notes: [2012] Some cracking and minor deterioration.
 [2014] Cracks at bridge joint that have been sealed. Cracks at Northeast corner due to settlement.

Photo 5 - Northeast corner with bituminous cracking due to settlement.

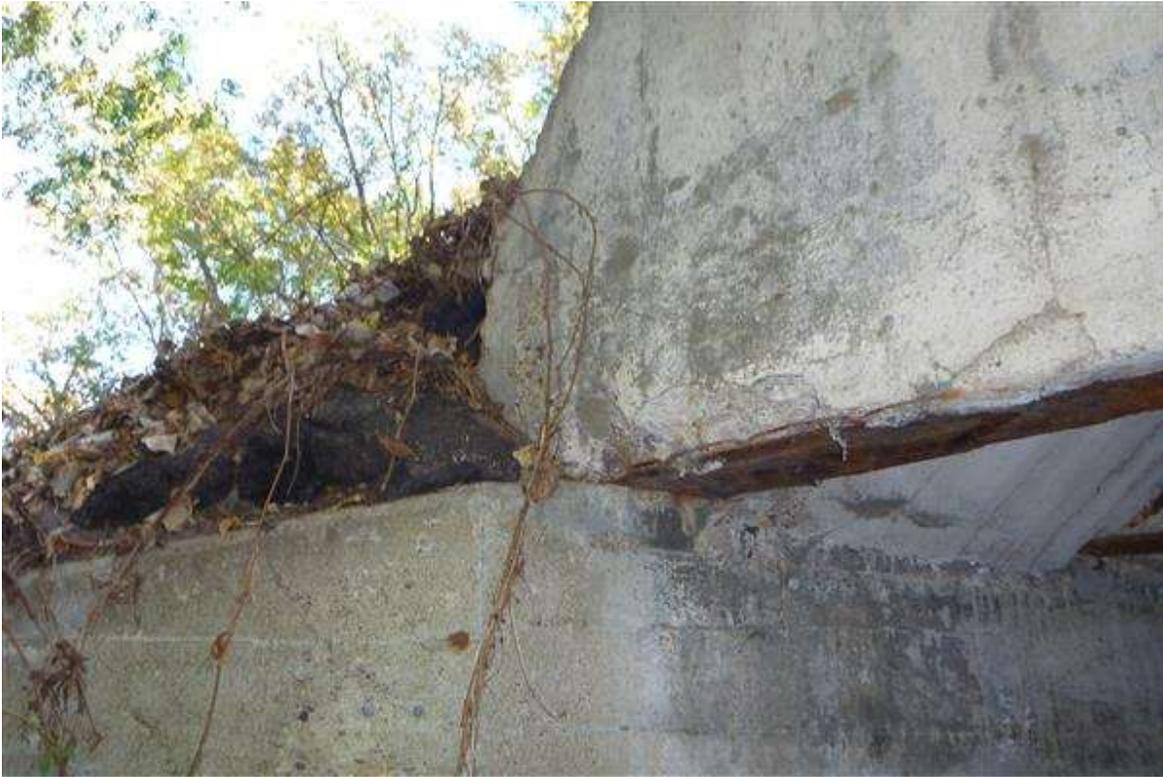
Photo 7 - Northeast corner. Railing spalled and bituminous fill crumbling below on ground.

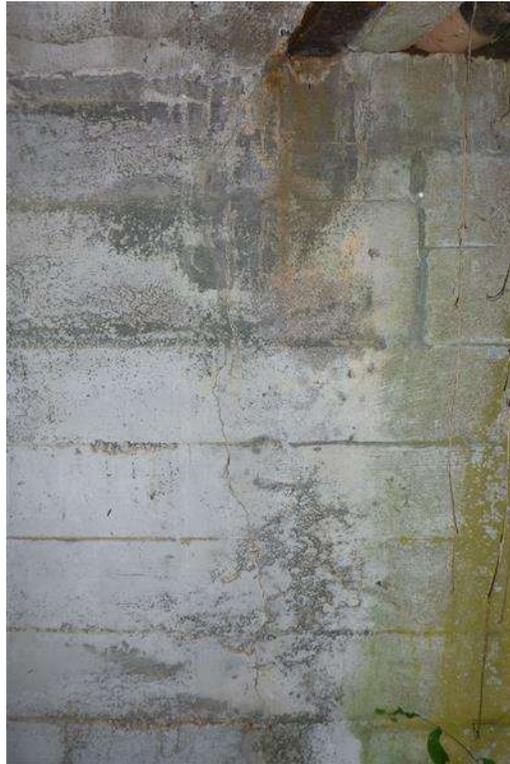
Notes: [2010] Vertical crack in SE abutment wall.
 [2014] SE crack in abutment wall is 1/16" - 1/8" wide. Does not appear to be getting worse.

Photo 8 - Southeast corner 1/16" to 1/8" wide crack.

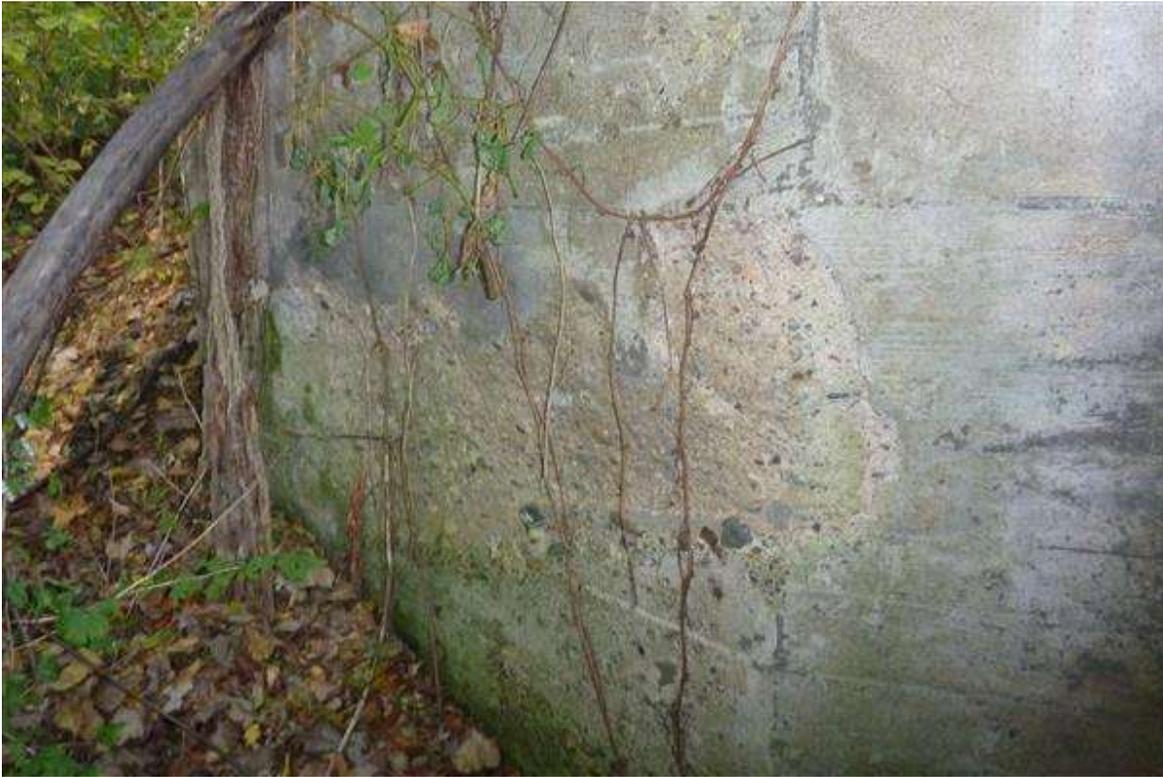
Photo 9 - Northeast Wingwall. Consists of large spall approximately 1" to 2" deep.

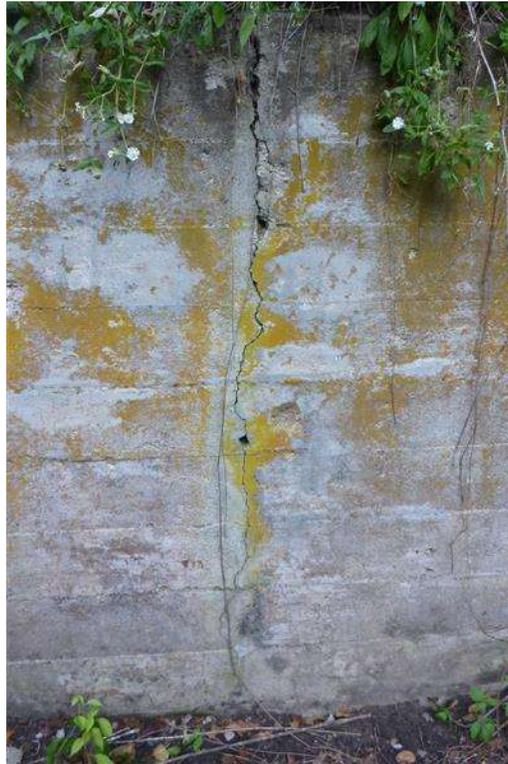
Photo 10 - Southeast Wingwall 1/8" - 3/16" vertical crack approximately 15 feet south of bridge.

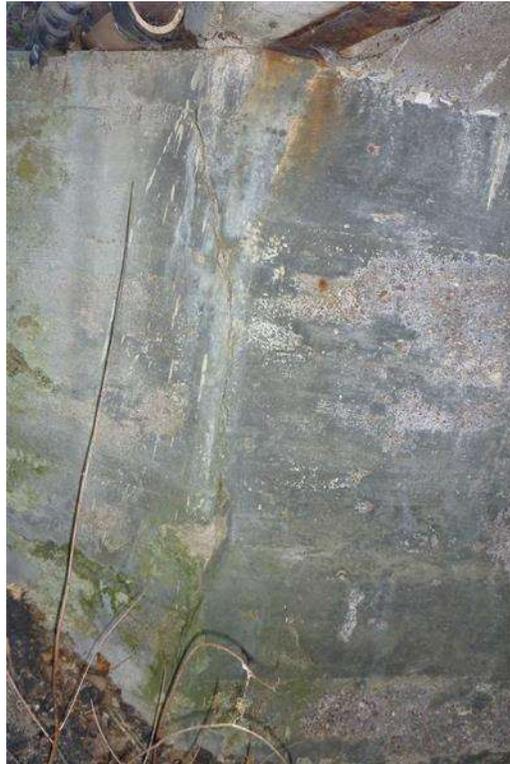
Photo 12 - Southwest Wingwall 1/16" vertical crack at wingwall and abutment.

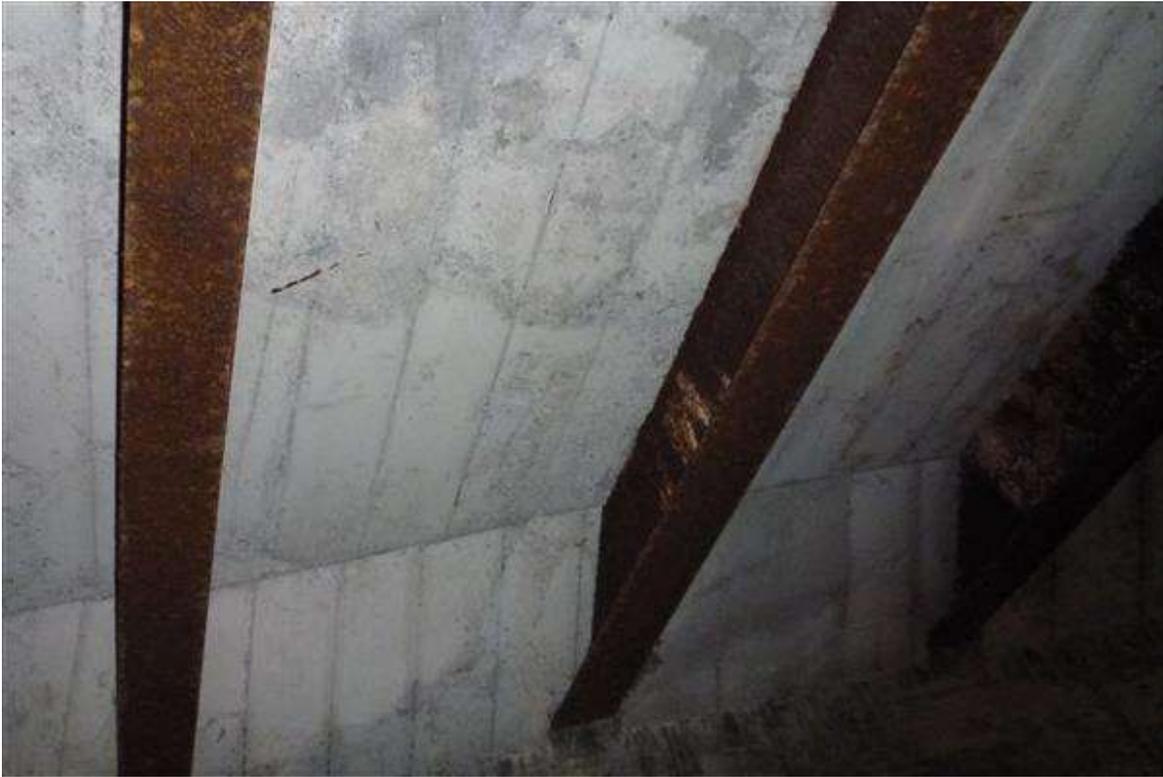
58. Deck NBI: [2014] Unable to see top of deck due to bituminous overlay. Deck has moderate delamination and spalling.

Photo 13 - Botom of deck.
