**2012 ROUTINE
BRIDGE INSPECTION REPORT**

**BRIDGE # L8167
TRADG PT TR S (22) over STREAM**

Date(s) of Inspection: 10/09/2012

**MnDOT Bridge Office
3485 Hadley Avenue North
Oakdale, MN 55128**

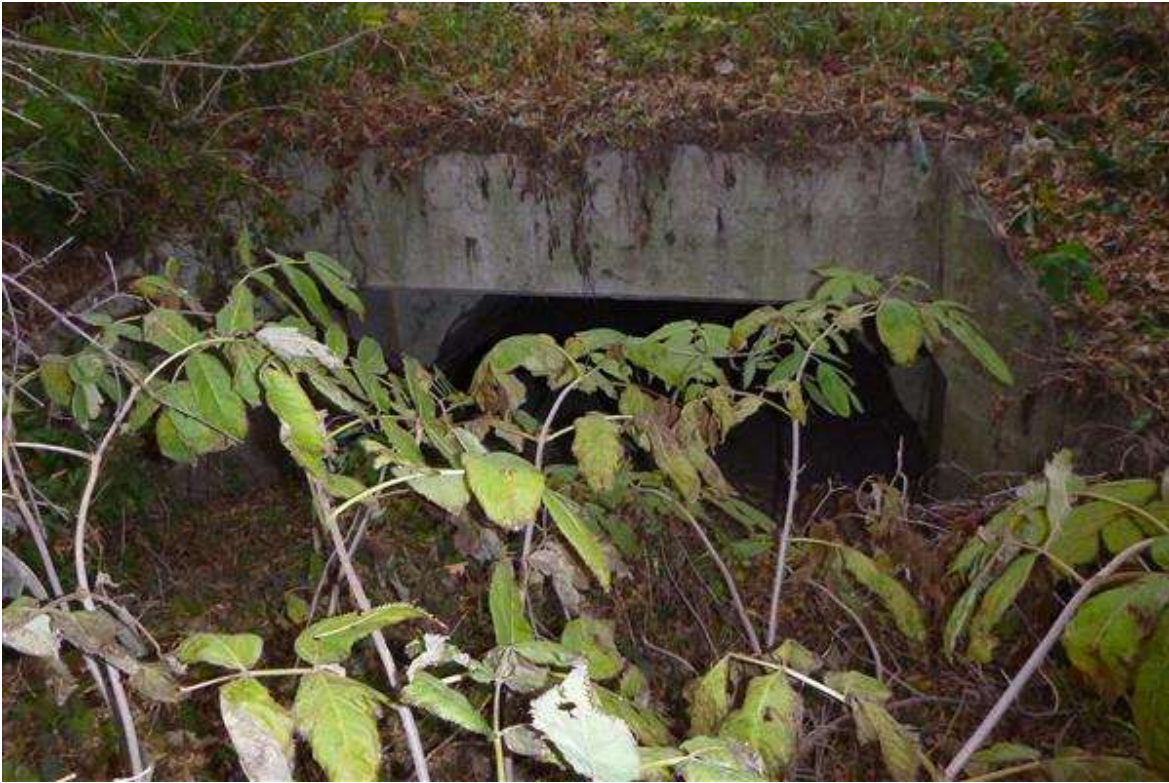
Photo 1 - west headwall looking east

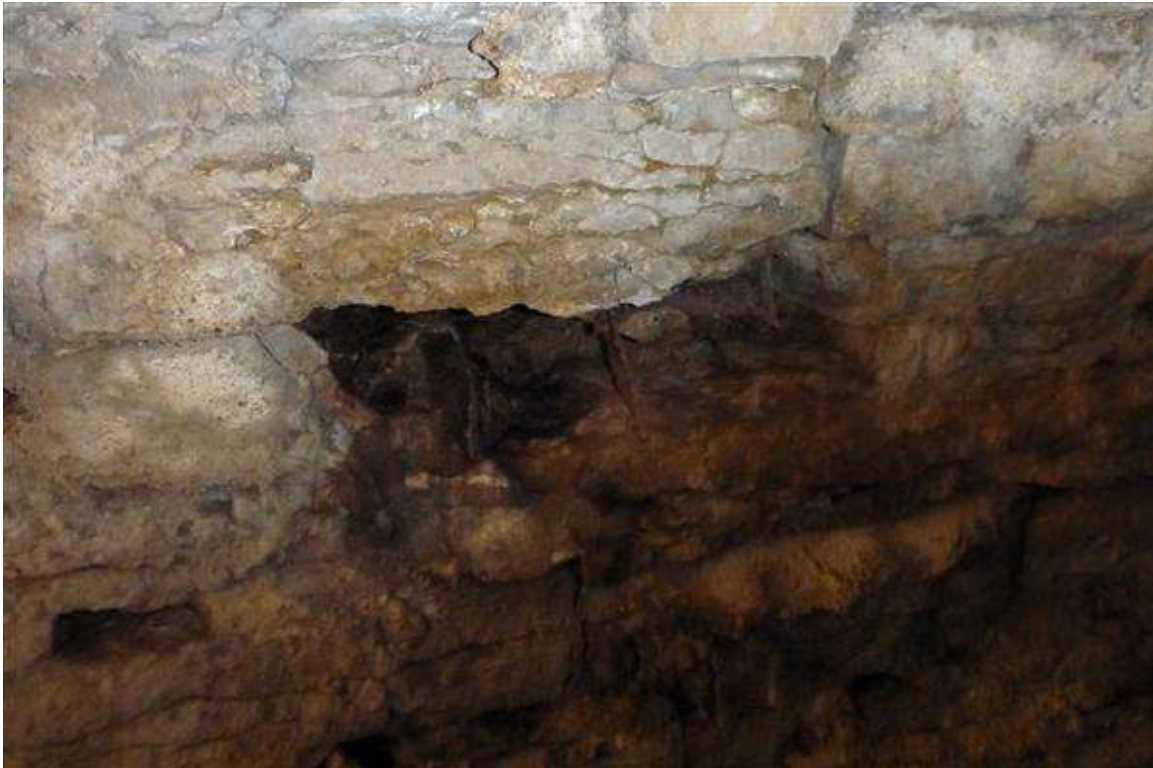
Photo 2 - missing stones near West Headwall

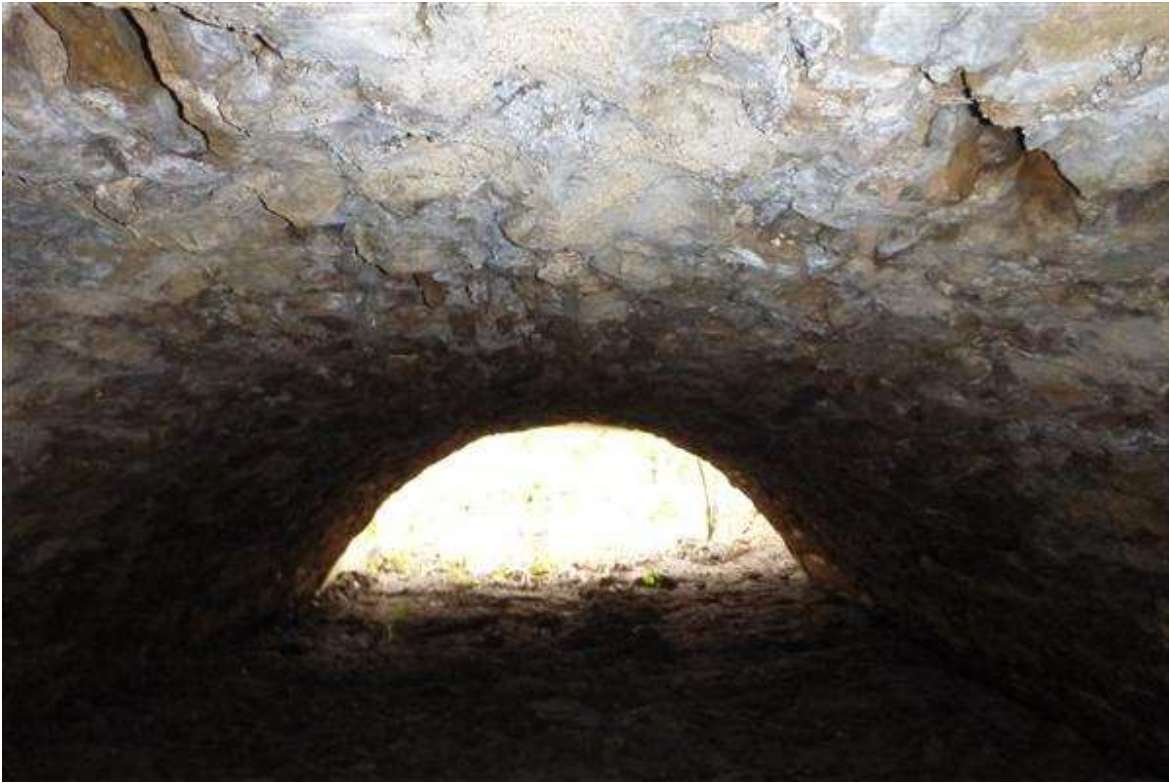
Photo 3 - masonry barrel looking east

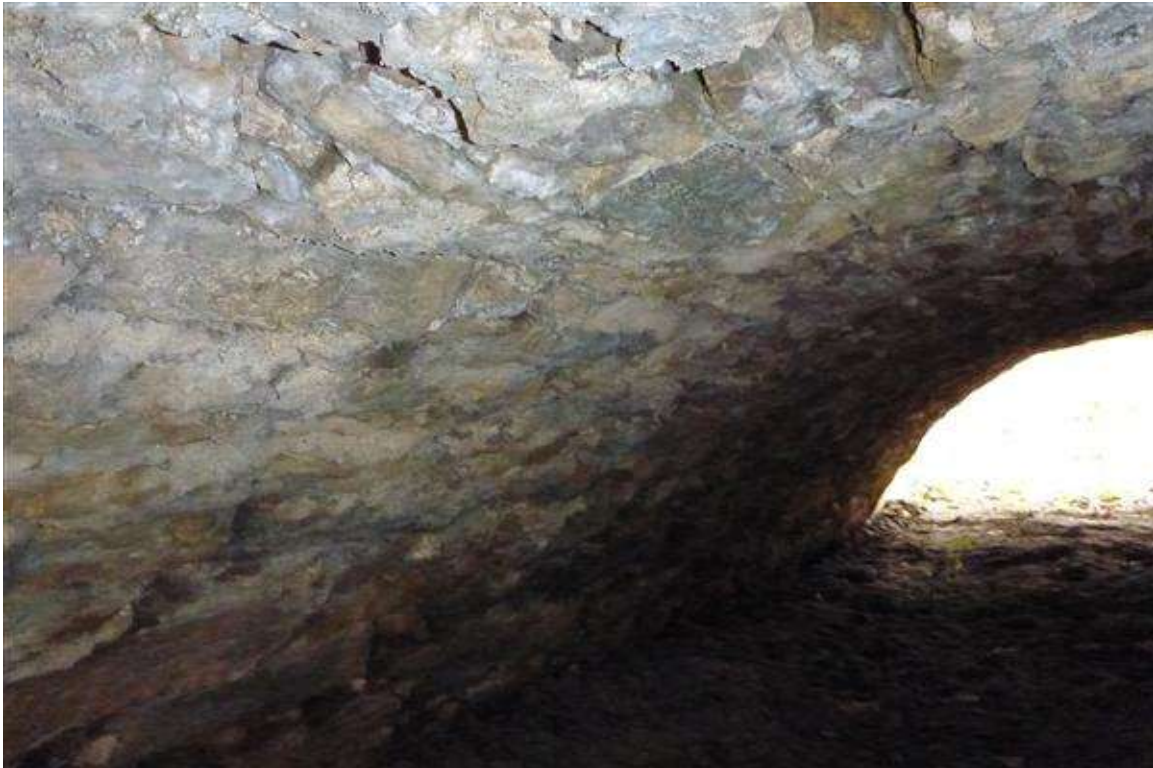
Photo 4 - masonry barrel looking northeast

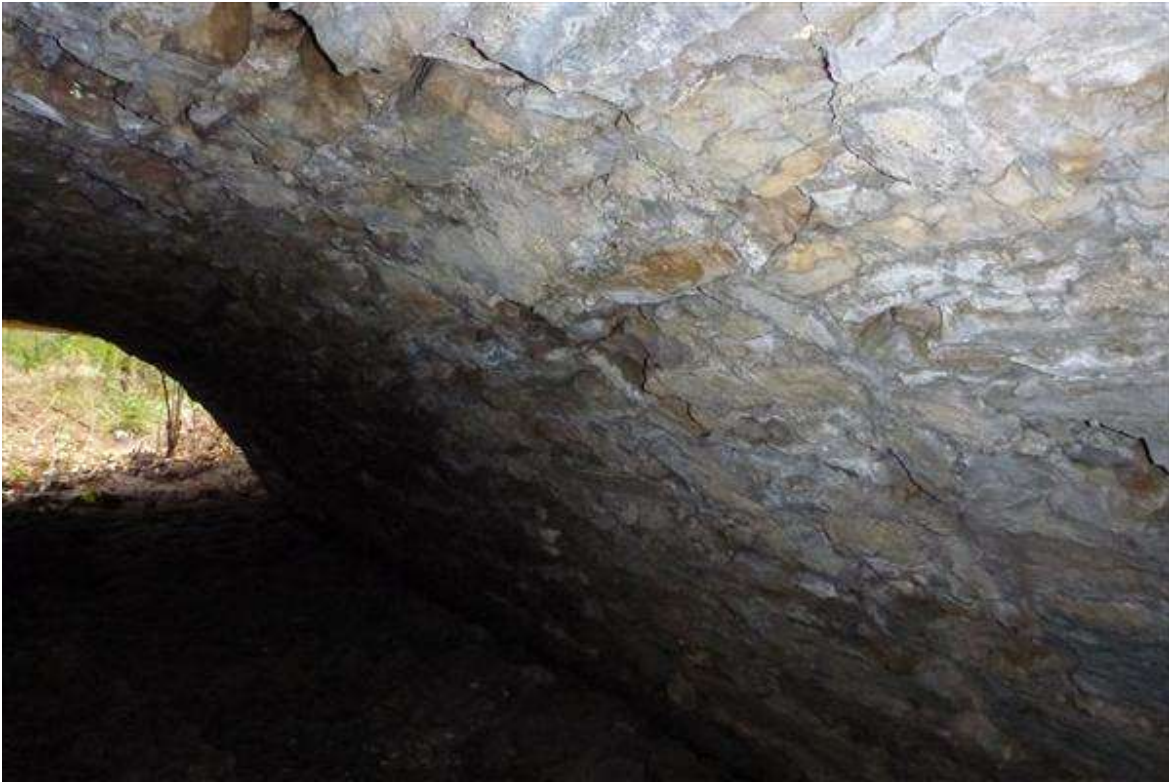
Photo 5 - masonry barrel looking southeast

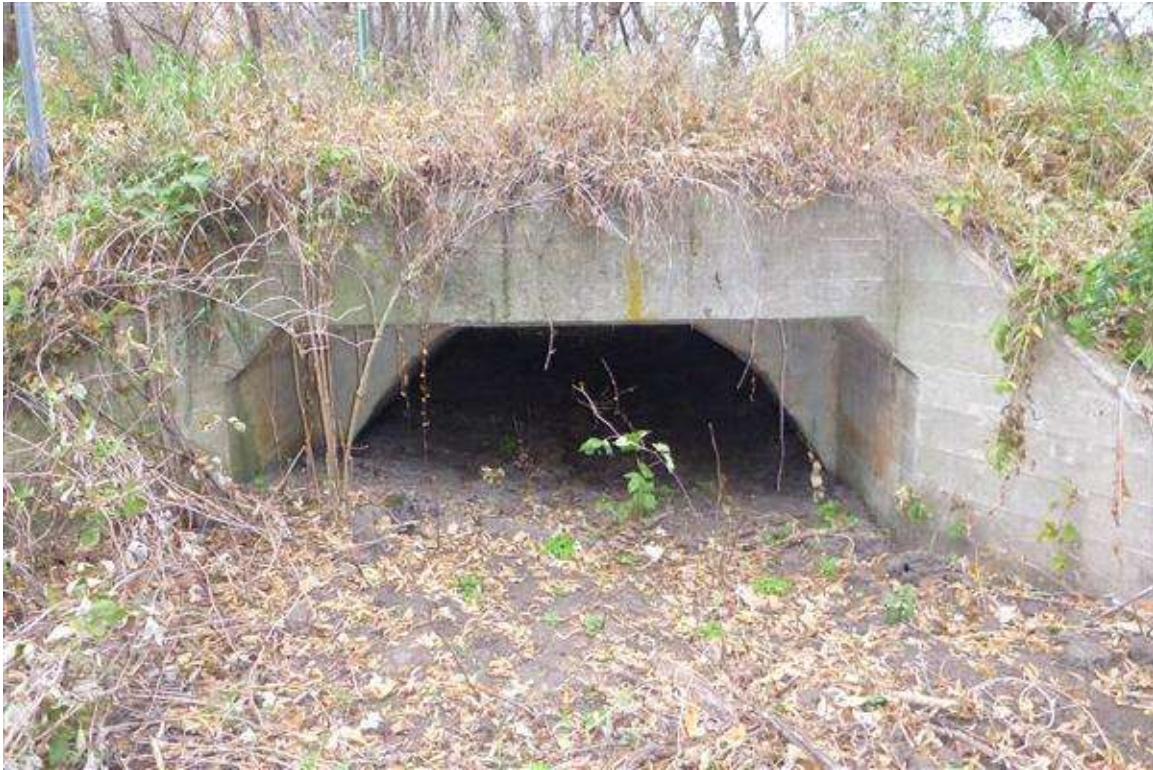
Photo 6 - east headwall looking west

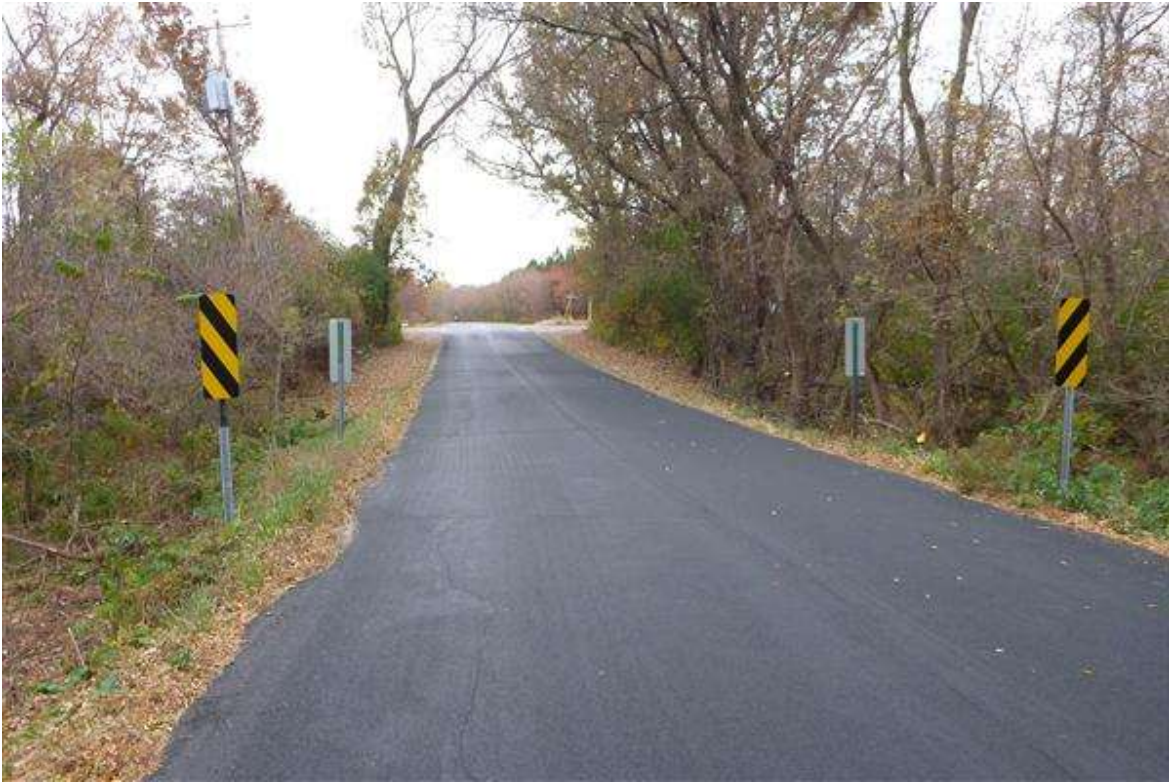
Photo 7 - Roadway over culvert looking south

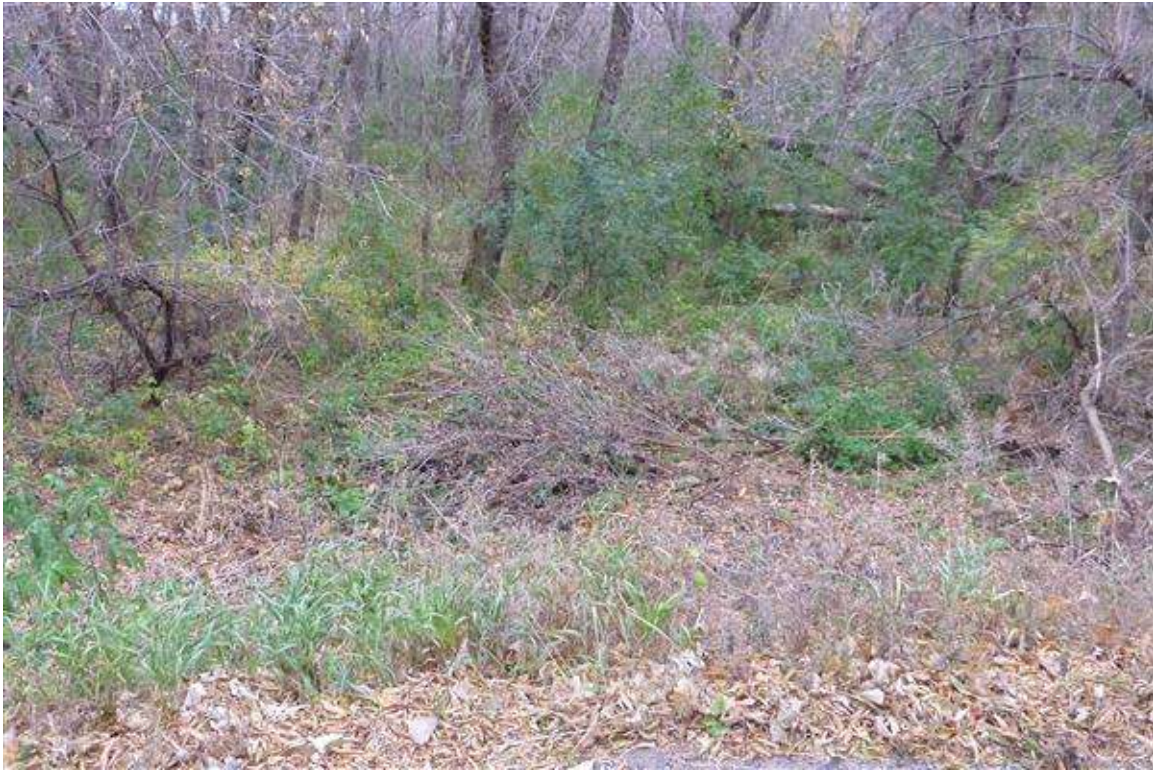
Photo 8 - channel looking east

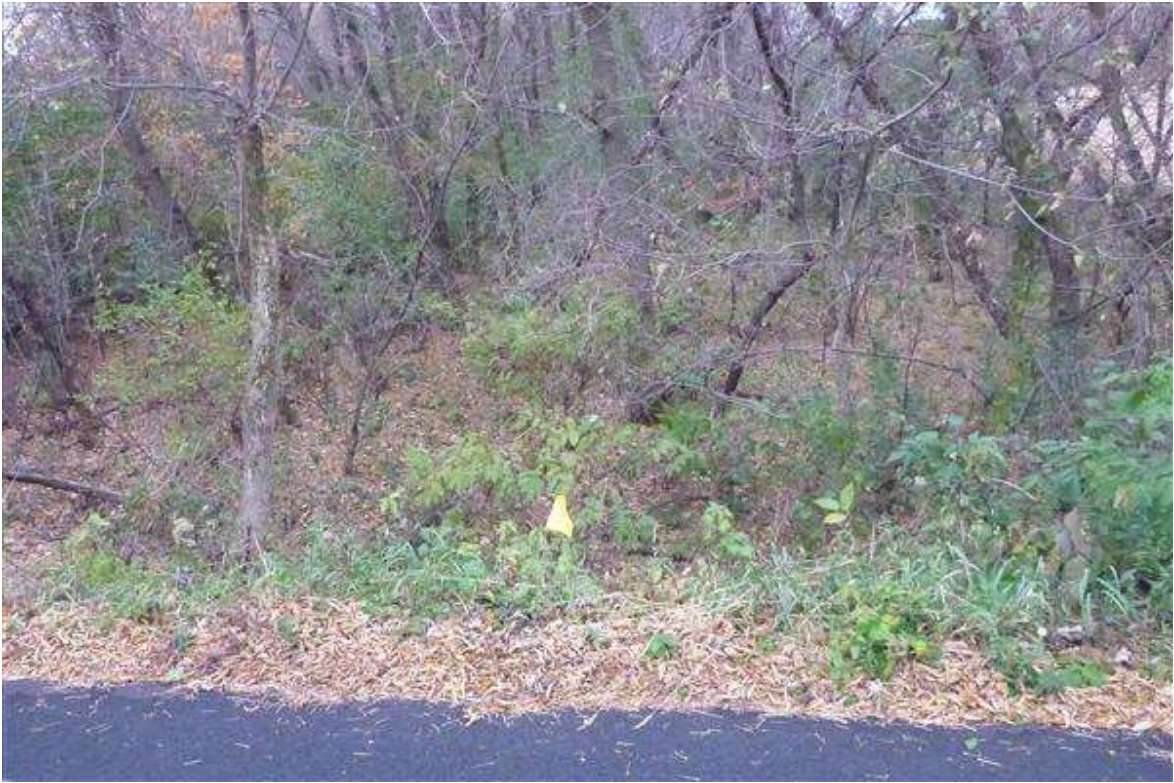
Photo 9 - channel looking west
