**2012 ROUTINE
BRIDGE INSPECTION REPORT**

**BRIDGE # L8170
VALLEY CRK TR (53) over VALLEY CRK (TRIBUTARY)**

Date(s) of Inspection: 10/09/2012

Inspected By: Lovelace, Barritt

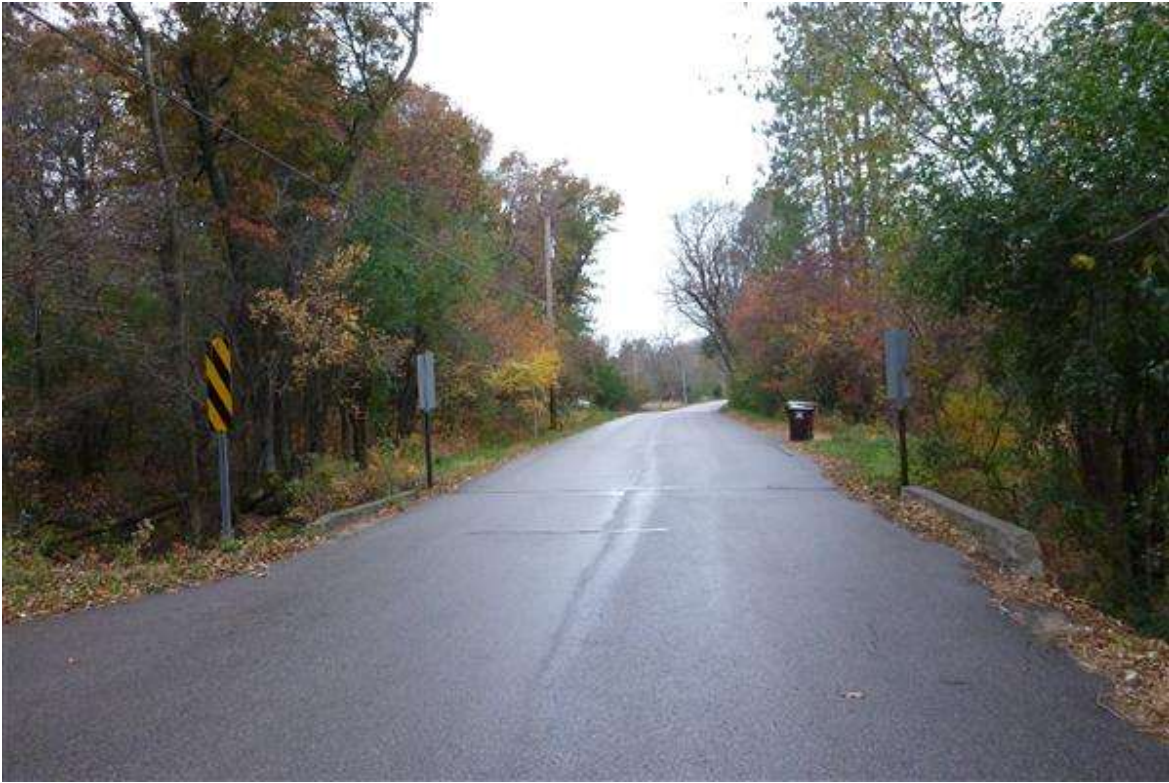
Photo 1 - Roadway over covert looking west

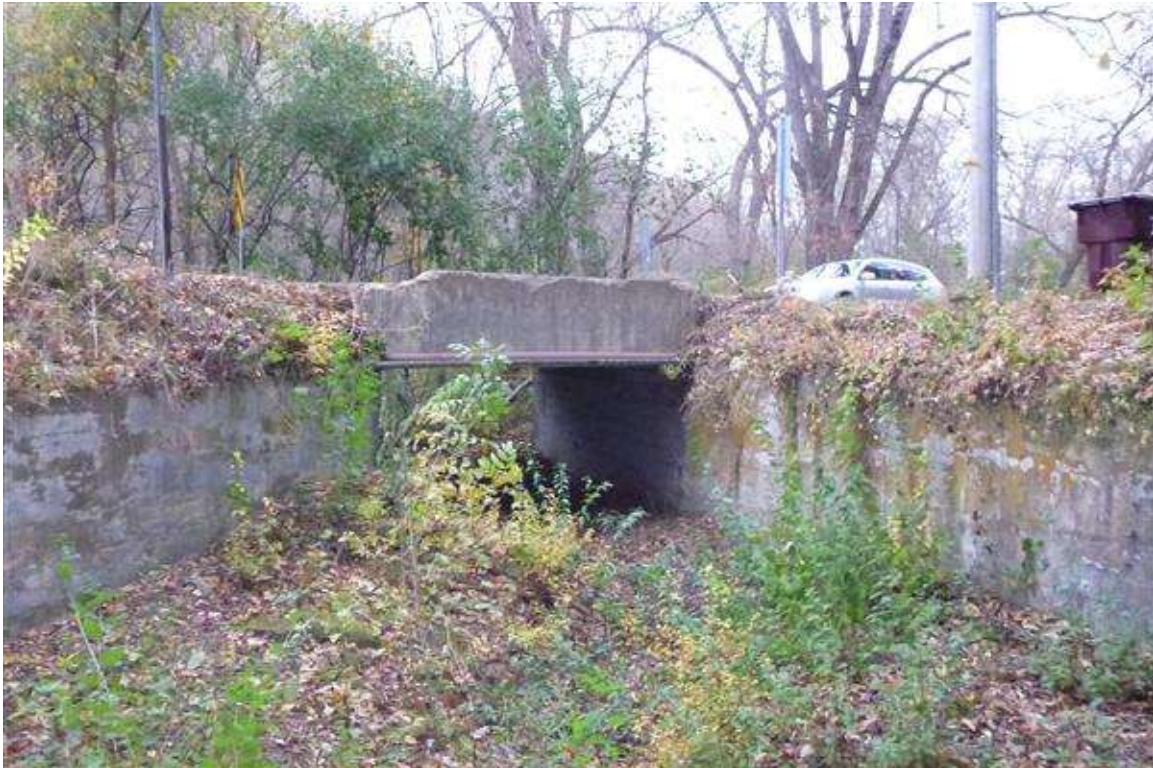
Photo 2 - upstream headwall looking north

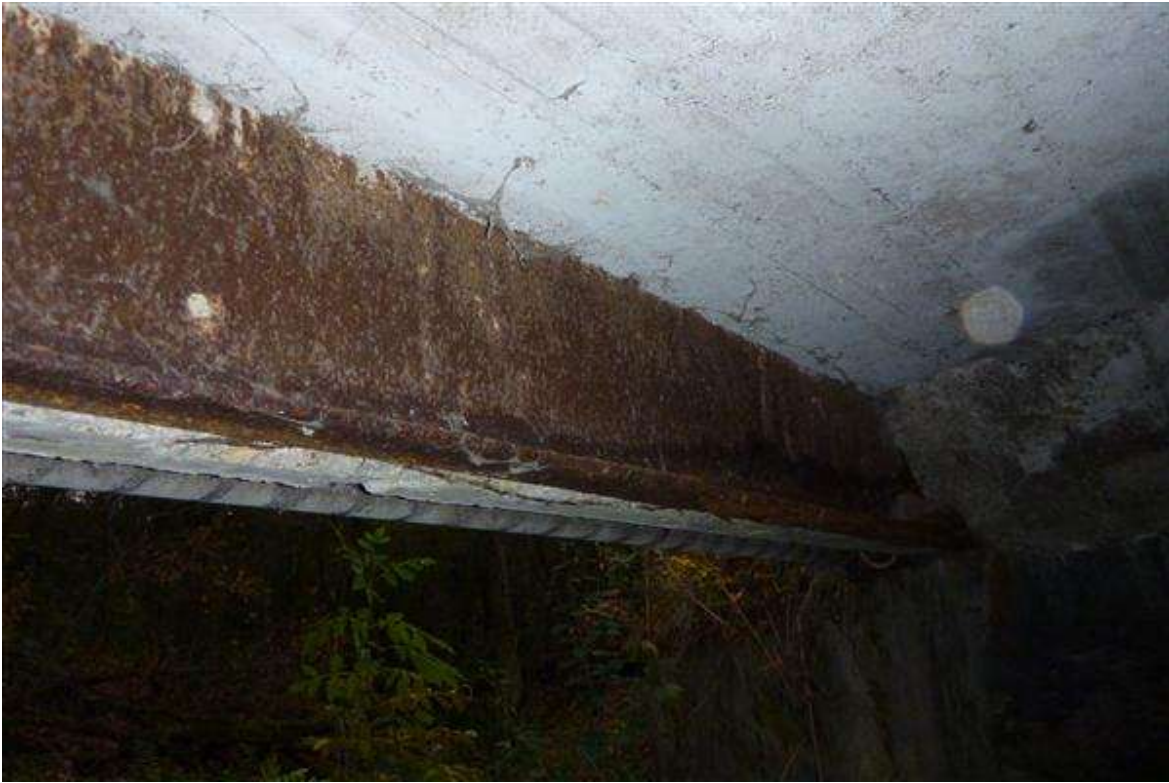
Photo 3 - south fascia beam looking south

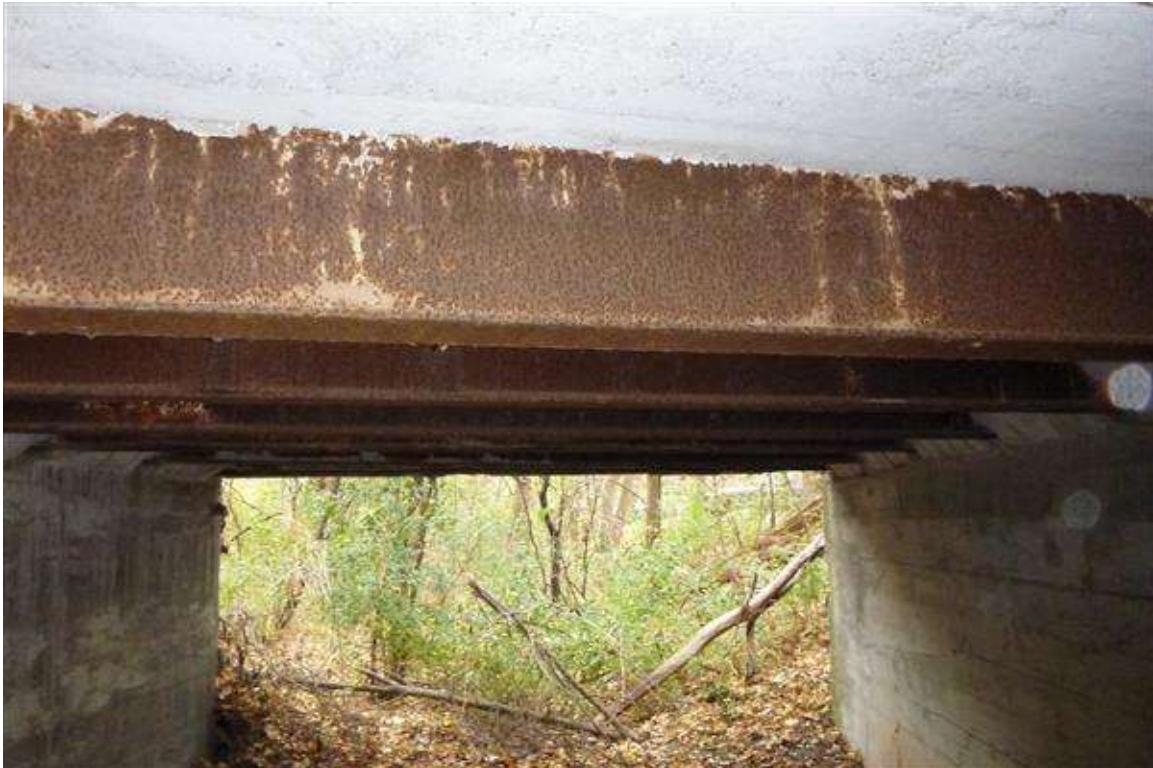
Photo 4 - steel beams looking north

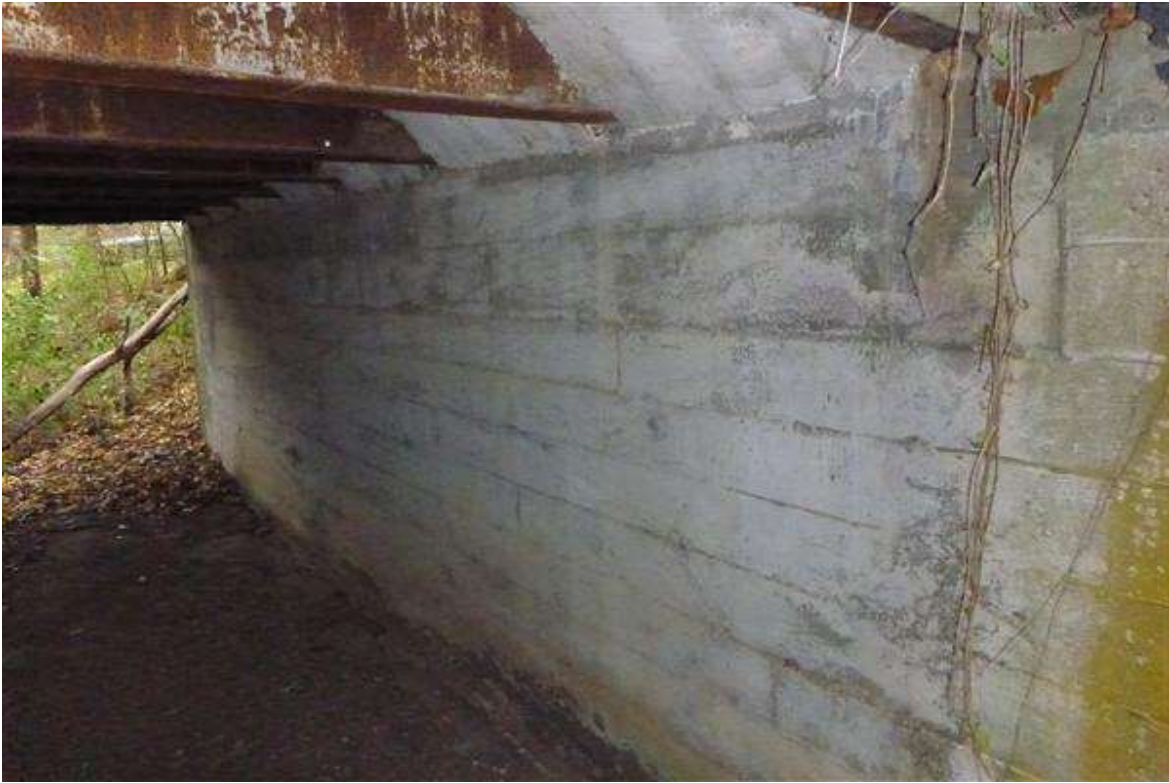
Photo 5 - west abutment looking southwest

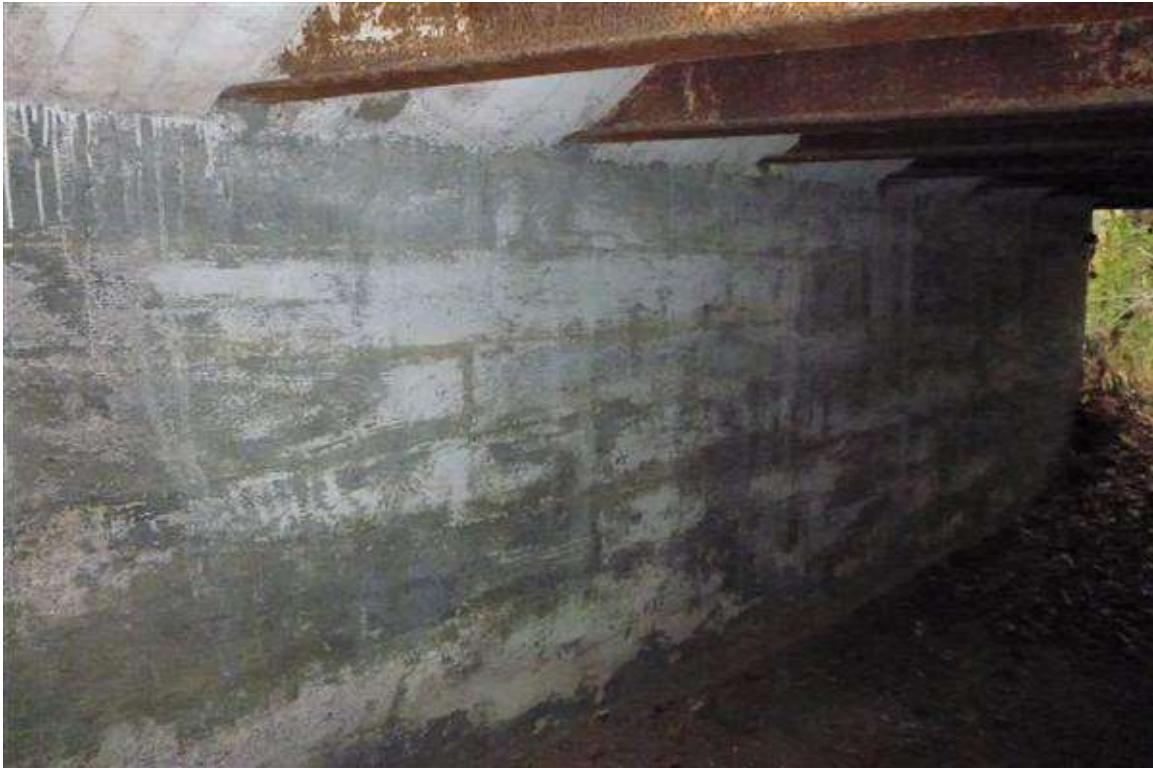
Photo 6 - East abutment looking southeast

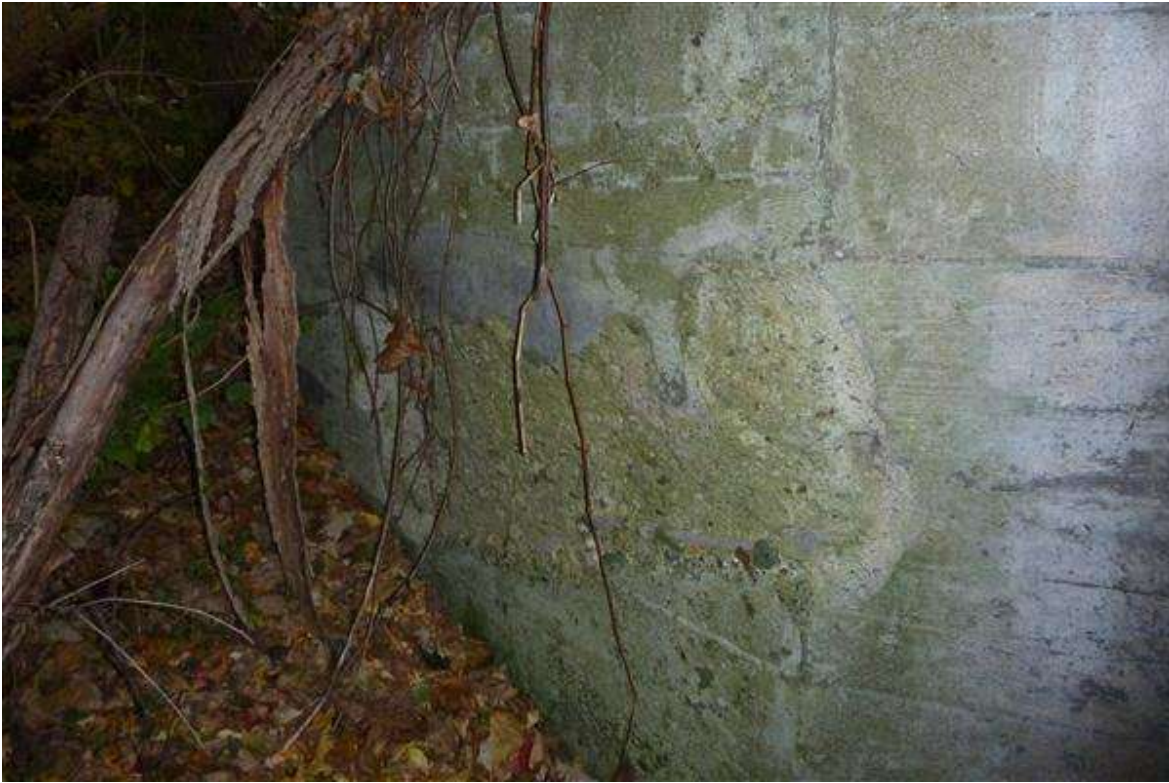
ELEM NBR	ELEMENT NAME	ENV	REPORT TYPE	INSP. DATE	QUANTITY	QTY CS 1	QTY CS 2	QTY CS 3	QTY CS 4	QTY CS 5
387	Reinforced Concrete Wingwall	2	Routine	10/09/2012	4 EA	2	2	0	0	N/A
			Routine	01/06/2012	4 EA	2	2	0	0	N/A
Notes: 2012 - NE wing shows surface wear. SE wing has vertical crack. No shifting or tilting noted.										
964	Critical Finding Smart Flag	2	Routine	10/09/2012	1 EA	1	0	N/A	N/A	N/A
			Routine	01/06/2012	1 EA	1	0	N/A	N/A	N/A
Notes: DO NOT DELETE THIS CRITICAL FINDING SMART FLAG.										
981	Signing	2	Routine	10/09/2012	1 EA	1	0	0	0	0
			Routine	01/06/2012	1 EA	1	0	0	0	0
Notes: [2007] New end markers added.										
984	Deck & Approach Drainage	2	Routine	10/09/2012	1 EA	0	1	0	N/A	N/A
			Routine	01/06/2012	1 EA	0	1	0	N/A	N/A
Notes: < none >										
985	Slopes & Slope Protection	2	Routine	10/09/2012	1 EA	0	1	0	N/A	N/A
			Routine	01/06/2012	1 EA	0	1	0	N/A	N/A
Notes: 2012 - Slopes are very steep. Minor erosion has occurred. There is no traffic barrier.

Photo 7 - north east wing wall

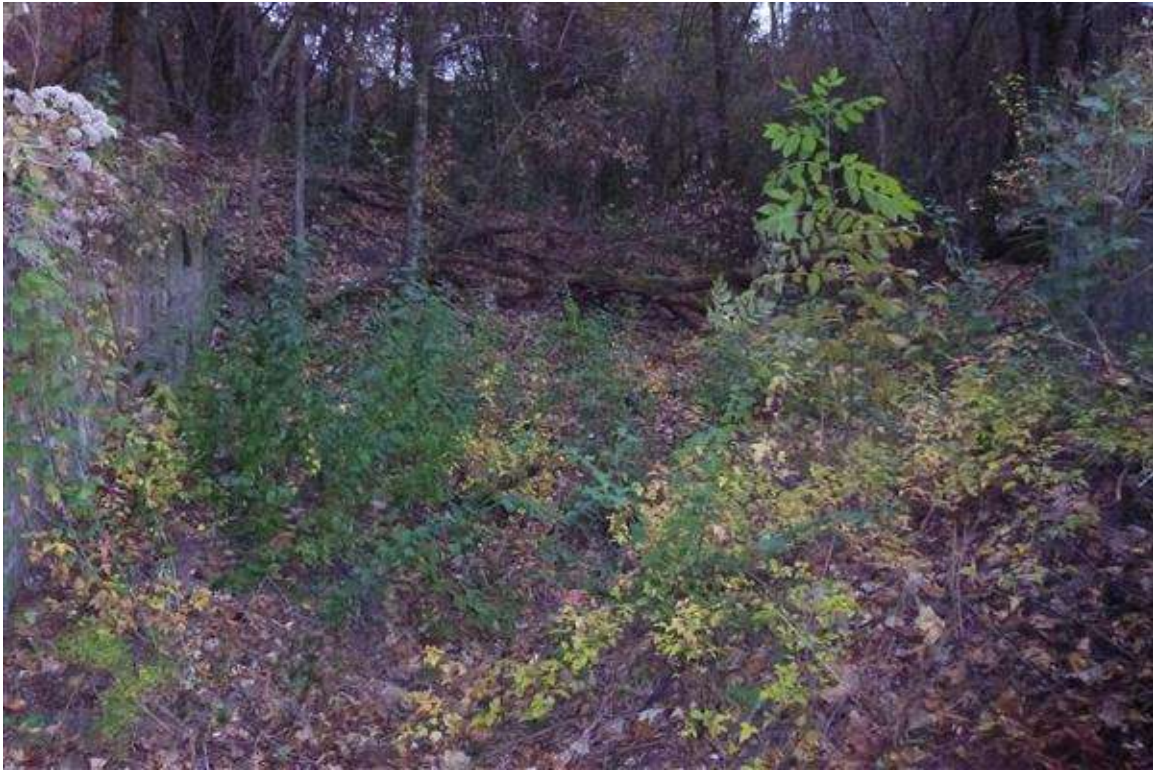
61. Channel NBI: Channel is typically dry and was dry at time of inspection.

Photo 8 - upstream channel looking south

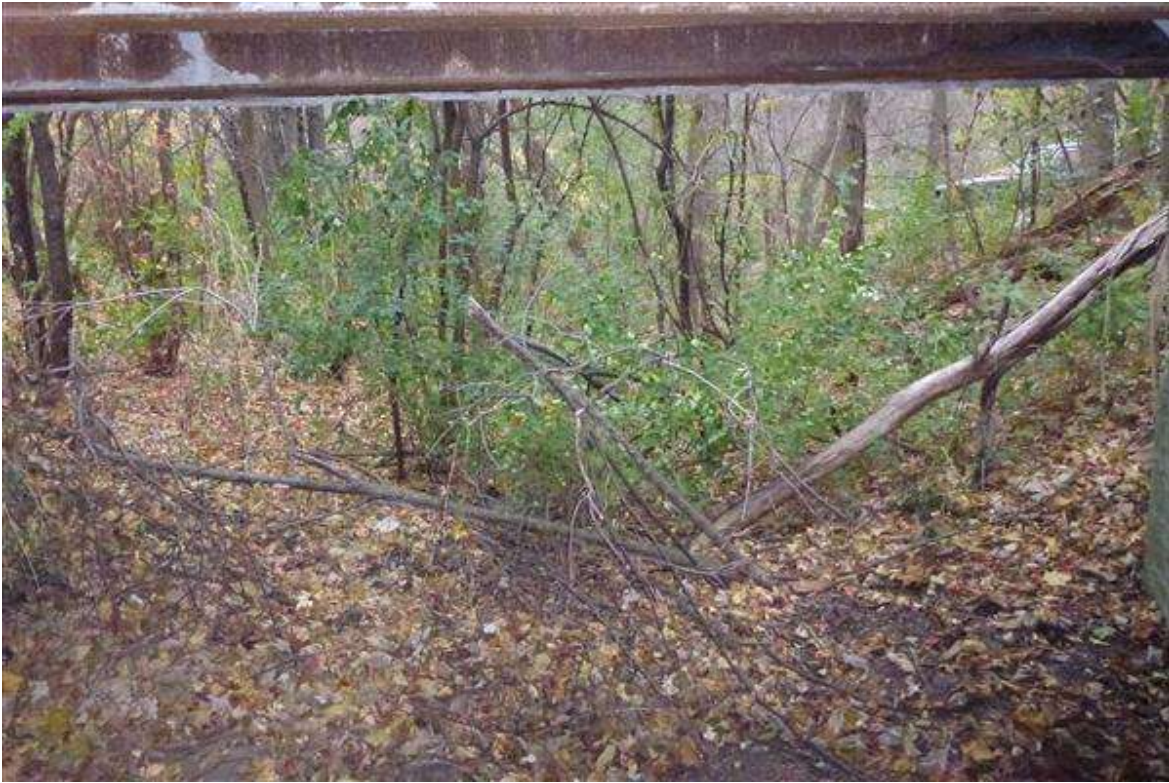
Photo 9 - downstream channel looking north

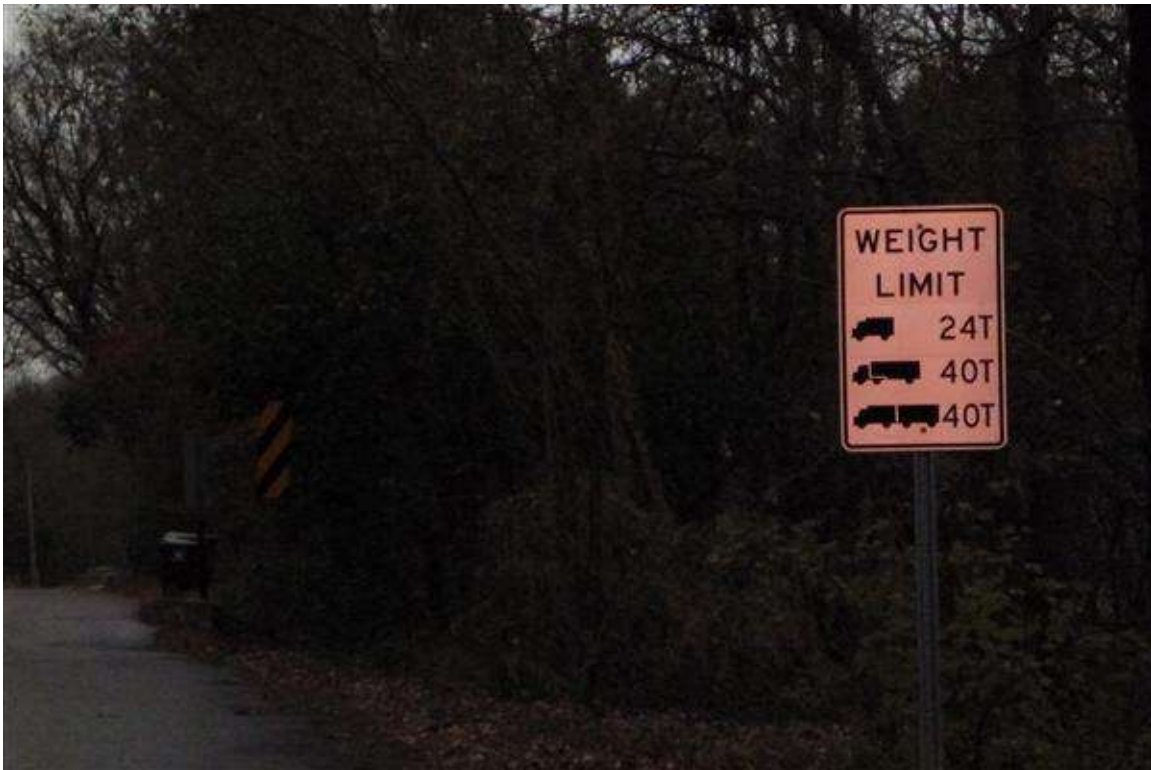
General Notes: 2012 - Bridge was load rated in 2012 and recently posted.

Photo 10 - recently installed load posting sign
